Inspection Report Minerals Regulatory Program Report Date February 8, 2006

Mine Name: Eagle Canyon Operator Name: Georgia Pacific Permit number: M/015/050 **Inspection Date:** January 20, 2006

M/015/050, Eagle Canyon Quarry, Georgia Pacific Inspection Dated: January 20, 2006; Report Dated: February 8, 2006

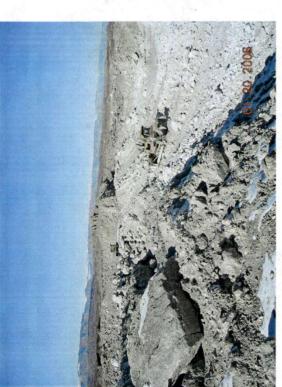
Two people were at the site. One of them was in a dozer pushing material up from one of the pits (Photos 1 and 3). We assume this material is being loaded and hauled to the plant in Sigurd where, we were told, the plant is being reactivated. The mine is active about two days a week.

Photo 1. The operator was pushing material up from one of the pits. A loader can be seen in the background.

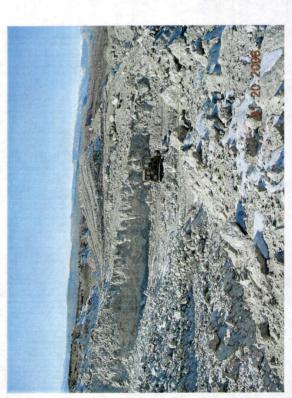
Photo 2. A small dozer in another pit.

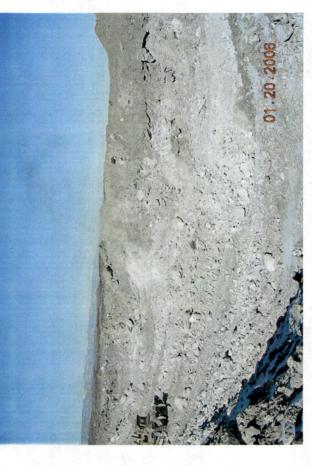
Photo 3. Another view of the pit in Photo 1. Note th soil on the right side of this picture.

There is soil in an area to the east of the active pit (see the right side of Photo 3), and if this pit is expanded in this direction, the operator needs to salvage this soil.
